HAMBURG DAM AND RESERVOIR

PHASE I INSPECTION REPORT NATIONAL DAM INSPECTION PROGRAM

HAMBURG RESERVOIR
BERKS COUNTY, PENNSYLVANIA
NATIONAL I.D. NO. PA 00718

Name of Dam: Hamburg Reservoir
County Located: Berks County
State Located: Pennsylvania
Stream: Furnace Creek
Coordinates: Latitude 40° 35.1' Longitude 75° 56.5'
Date of INSpection: 18 July 1978

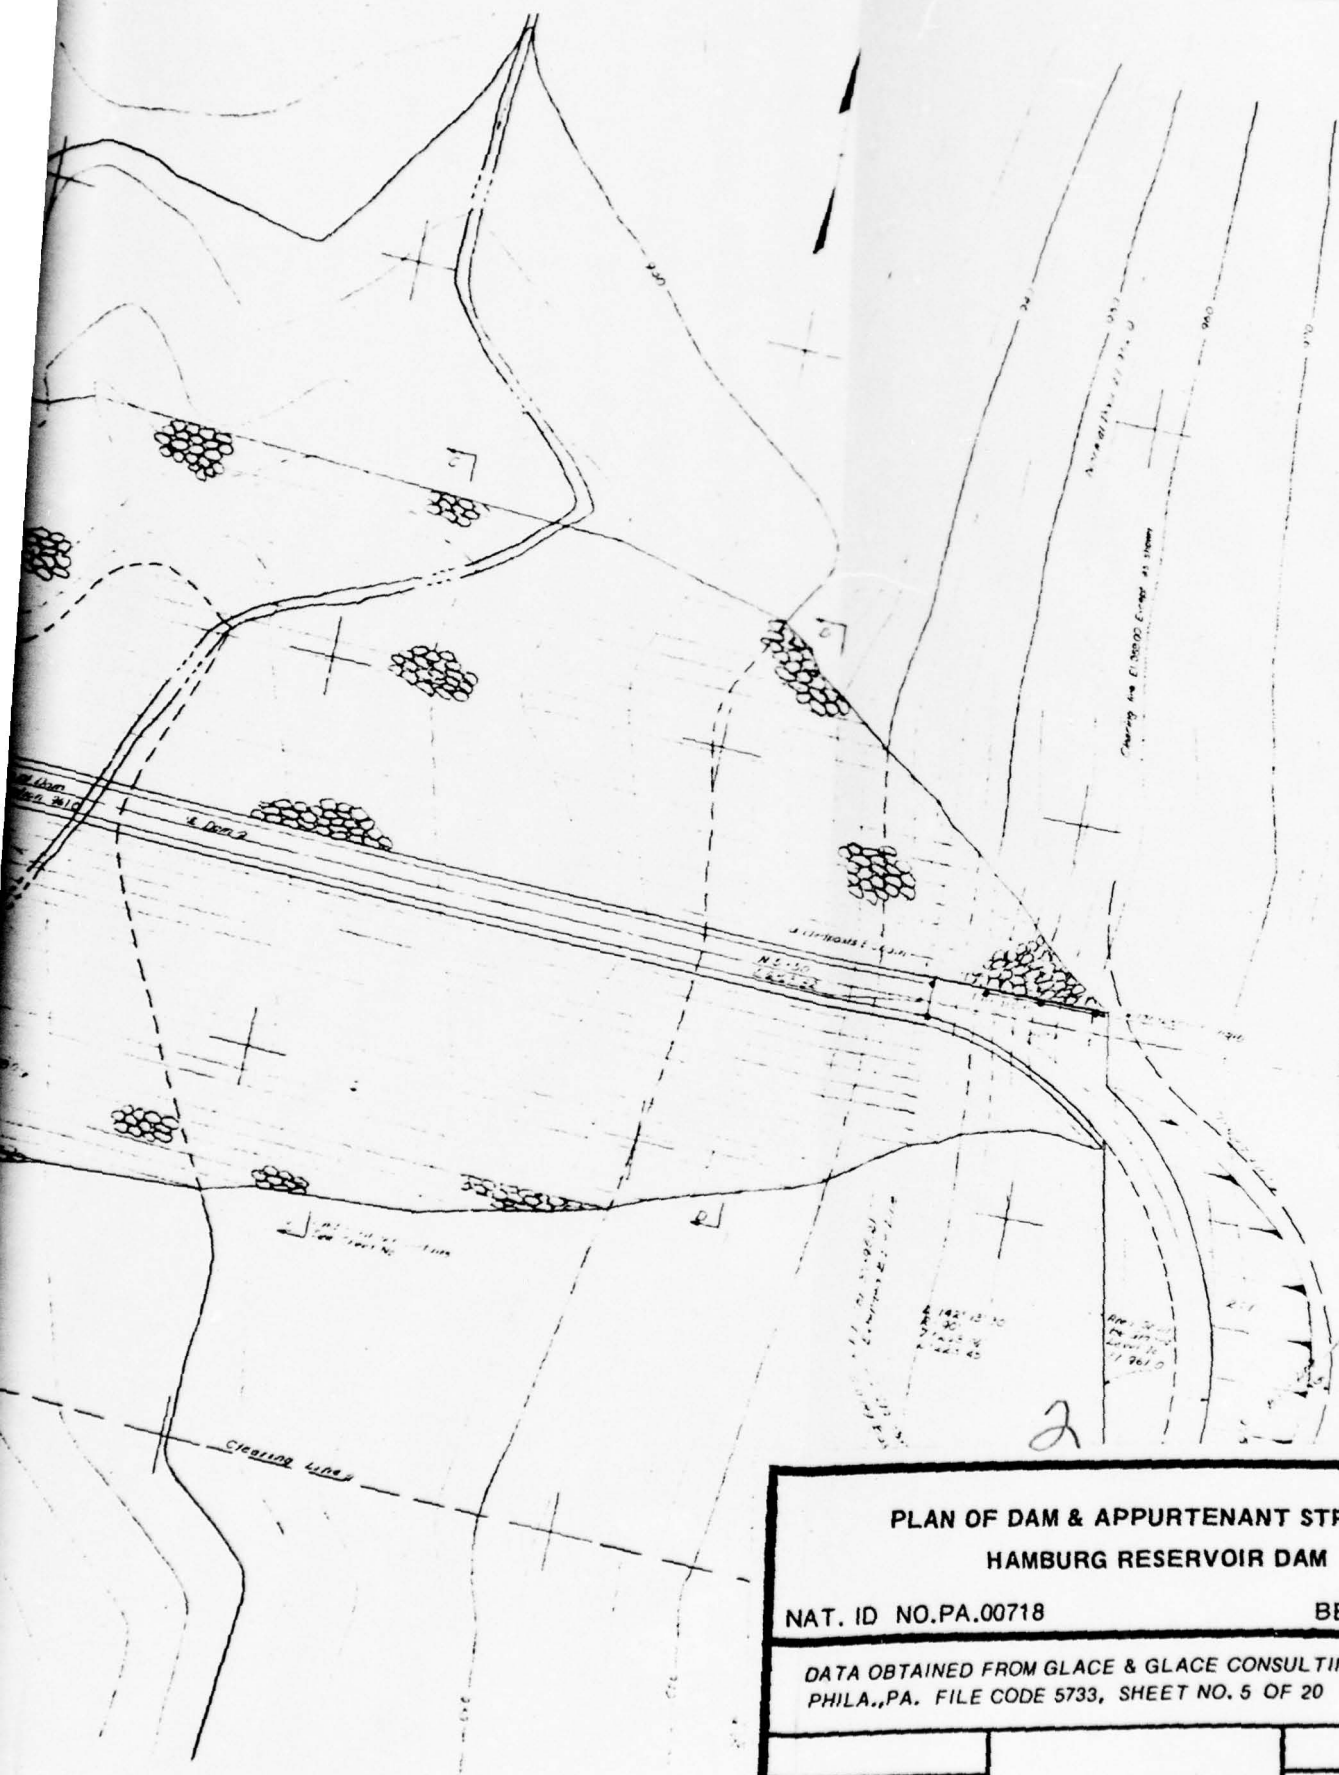
PLATE 2

h. Normal Operating Procedures. Under normal operating conditions, the reservoir overflow is controlled by the spillway located at the right abutment (crest elevation 952.0). Water for the City of Hamburg is drawn off through the control tower by means of two intakes located at elevations 945 and 935. The intake pipes converge to a single 8-inch pipe through the embankment, down the valley and into a water treatment facility. The pond drain intake is at the base of the intake tower, controlled by a 30-inch sluice gate discharging through a 30-inch concrete pipe. The sluice gate valve is located atop the intake tower and the 30-inch pipe discharges into an impact basin at the downstream toe, as shown on Plate 2, Appendix E, entitled "Plan of Dam and Appurtenant Structures."

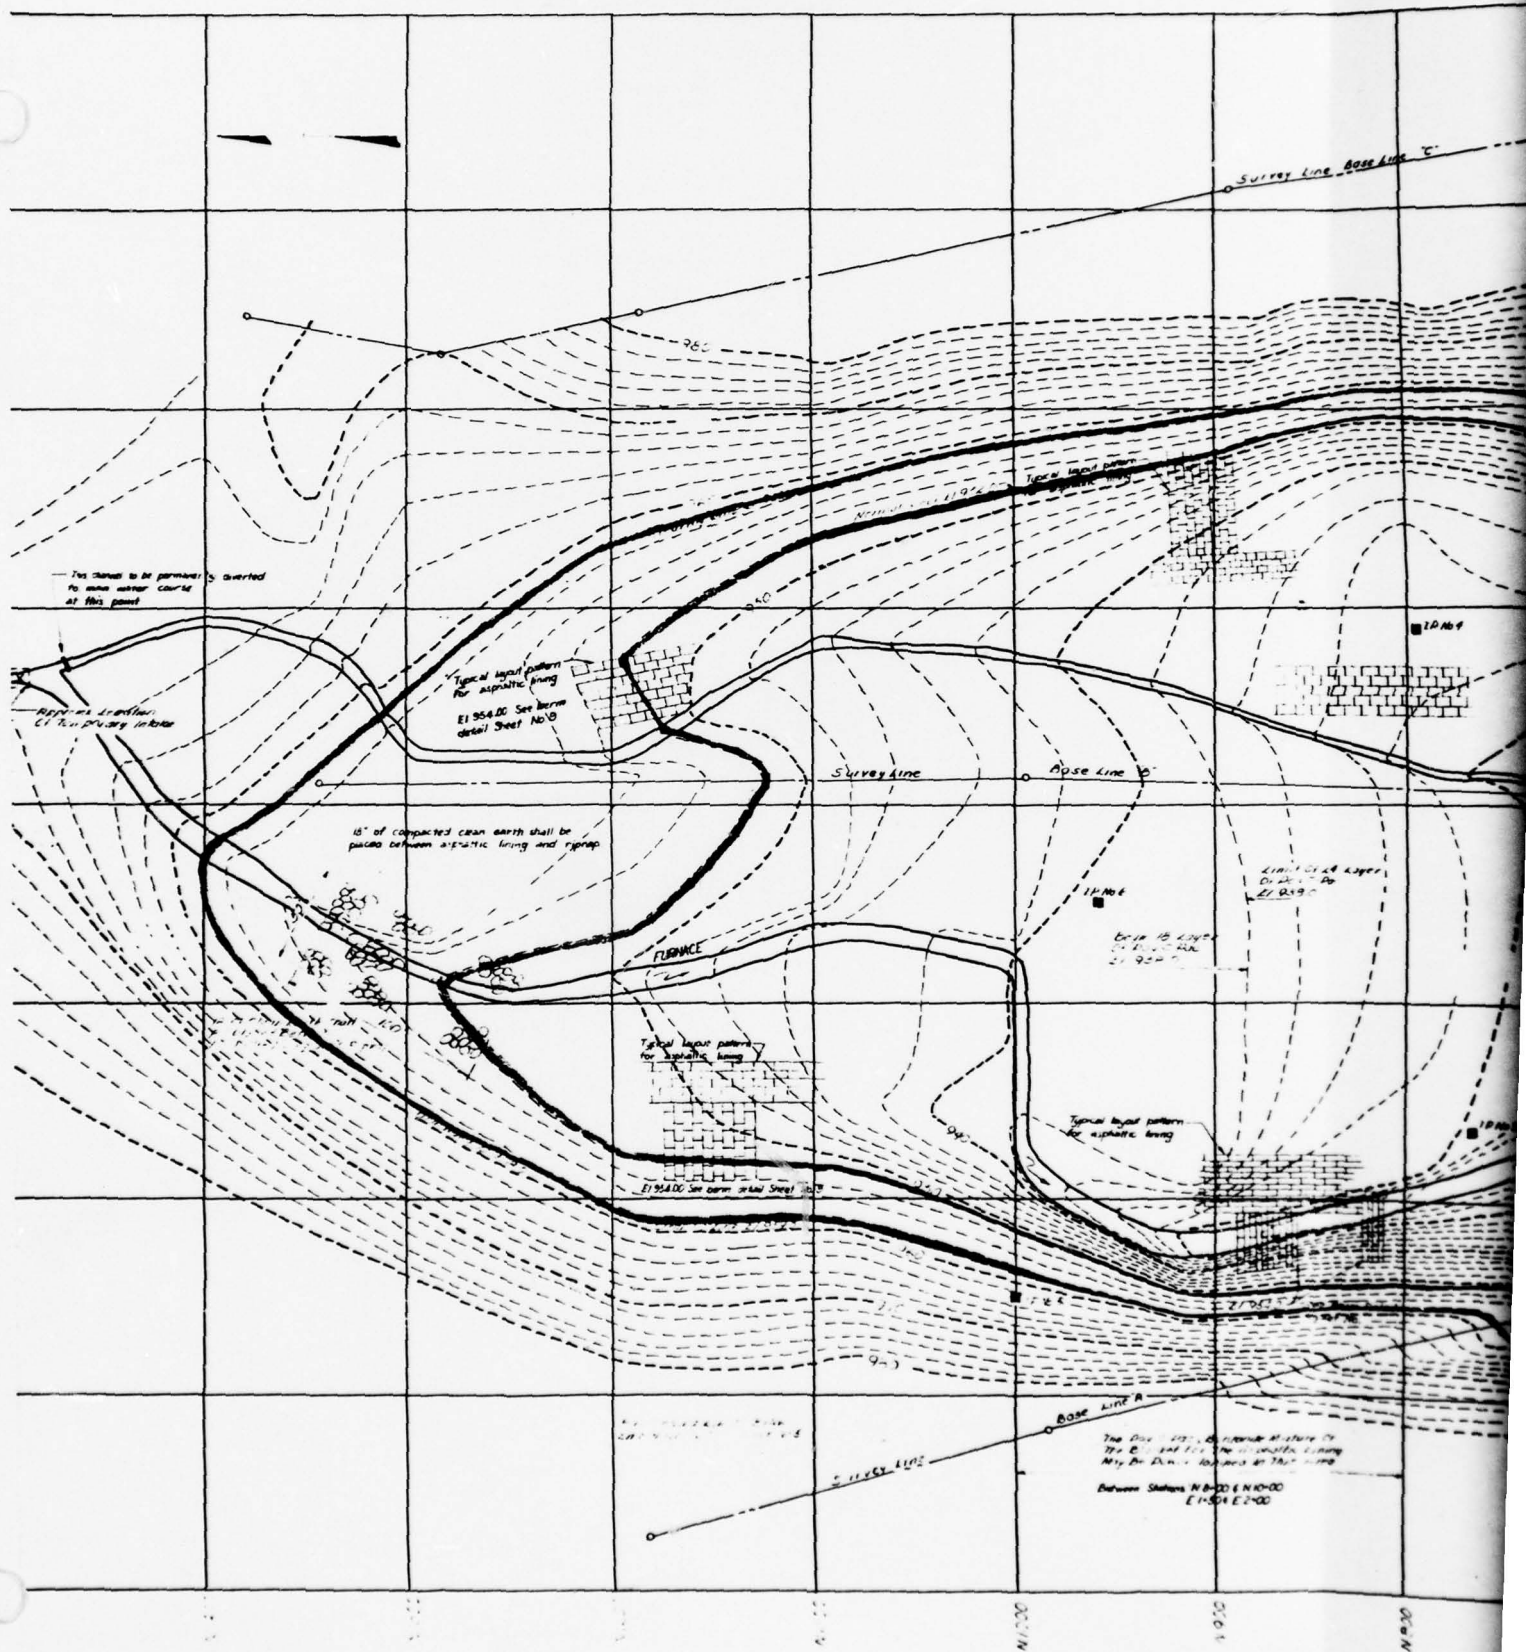
The intake tower is shown on Plate 7, Appendix E. Water enters the tower through two 16-inch sluice gates into an 8-inch cast iron pipe, through the embankment to the water treatment plant approximately 1/2 mile downstream. Excess water is discharged over the spillway at the right abutment of the structure. The reservoir can be drawn down by opening the 30-inch sluice gate at the base of the tower. Water is discharged through a 30-inch precast concrete outlet into an impact basin at the downstream toe. Water from the pond drain and the spillway converge 250 feet downstream into Furnace Creek.

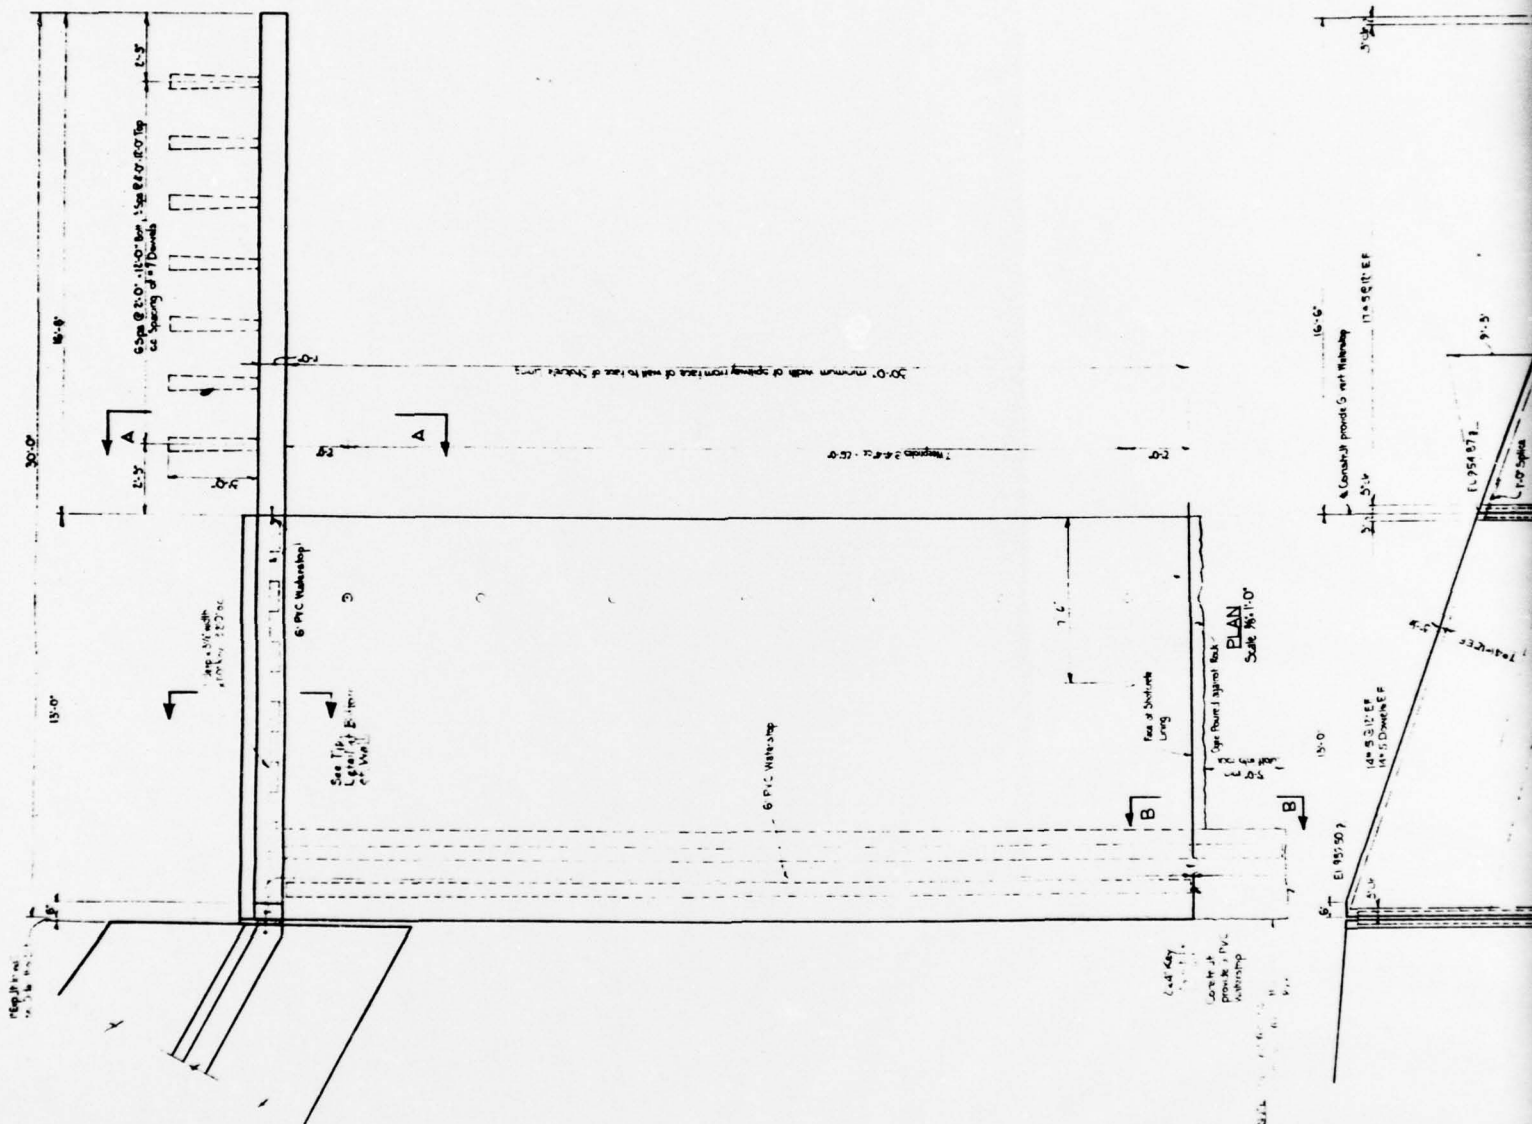
<p align="center">SPILLWAY WEIR DETAILS HAMBURG RESERVOIR DAM</p>		
<p>NAT. ID NO. PA.00718</p>		<p>BERKS COUNTY</p>
<p>DATA OBTAINED FROM GLACE & GLACE CONSULTING ENGINEERS, PHILA., PA. FILE CODE 5733, SHEET NO. 15 OF 20</p>		
		<p align="center">PLATE 9</p>

is located about 35 feet downstream of the dam centerline. The height of the left spillway wall is 7.5 feet (Plate 9) above the weir crest (elev. 952), thus the maximum reservoir elevation is 959.5+ feet. Observations regarding the condition of the downstream channel, spillway conditions, and reservoir are located in Appendix B.
